Manhole Inspection Summary

Manhole # S51CC_003MH

Location Address: **2812 e madison st**

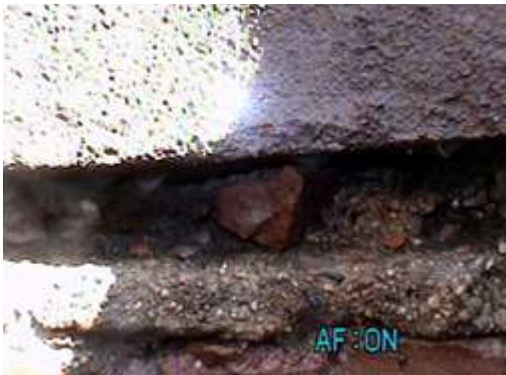
Defect 2

Condition: ☐ Sound ☒ **Cracked** ☐ Root Intrusion ☒ **Loose Brick** ☒ **Deteriorated**

frame adj cracked, loose bricks,
deteriorated

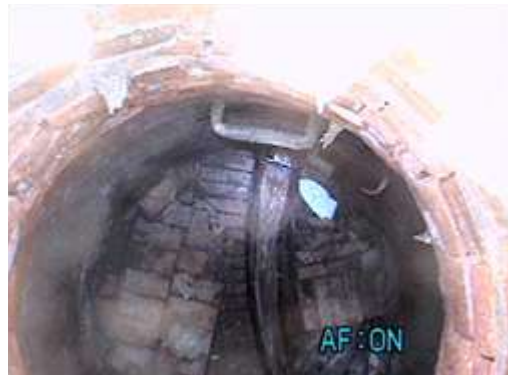
Defect 1

Count: **4** Missing: **3** ☒ **Corroded**

missing/corroded steps

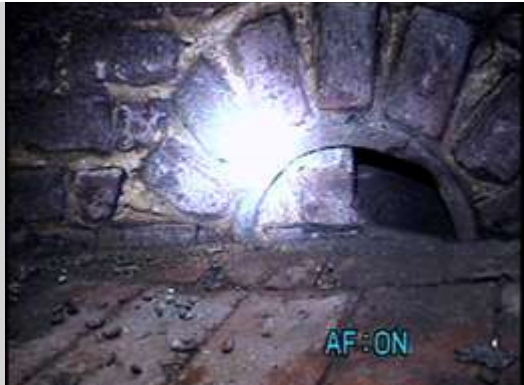
3 O'Clock Inflow

bricked off

Connects To: **Stub connection / abandoned**
